GLOBAL ADVANTECH LIMITED – CASE STUDY

Heavy Duty Rubber Deposit Remover IP701, Industrial Hard Surface Cleaner IP712

Chemical Manufacturing plant trial

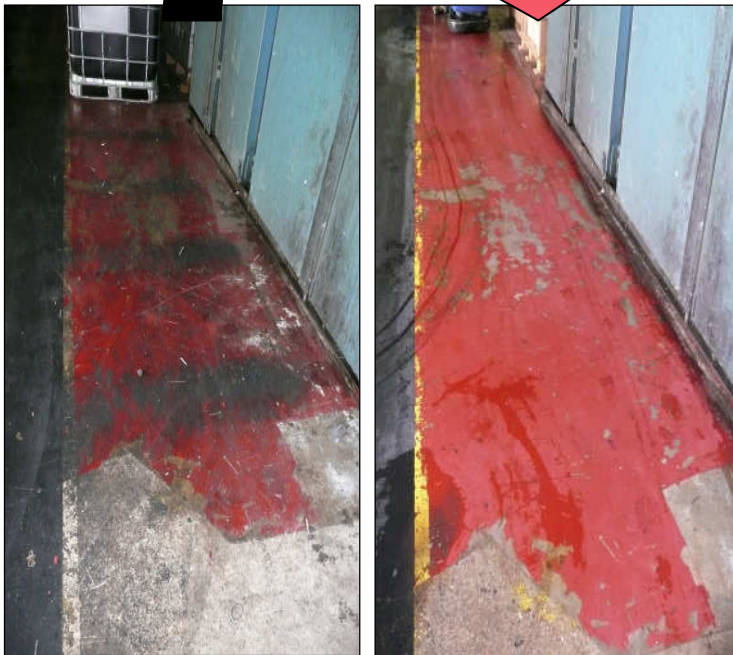
Area 1 treatment details

Heavy Duty Rubber Deposit Remover IP701 was applied with a mop across a floor area coated with a badly damaged red epoxy surface and covered in places with rubber tyre deposits more than 1 mm thick, directly in front of two drum ovens. The Heavy Duty Rubber Deposit Remover left for 5 minutes and then removed using a scrubber-drier machine charged with a 2% solution of Industrial Hard Surface Cleaner IP712.

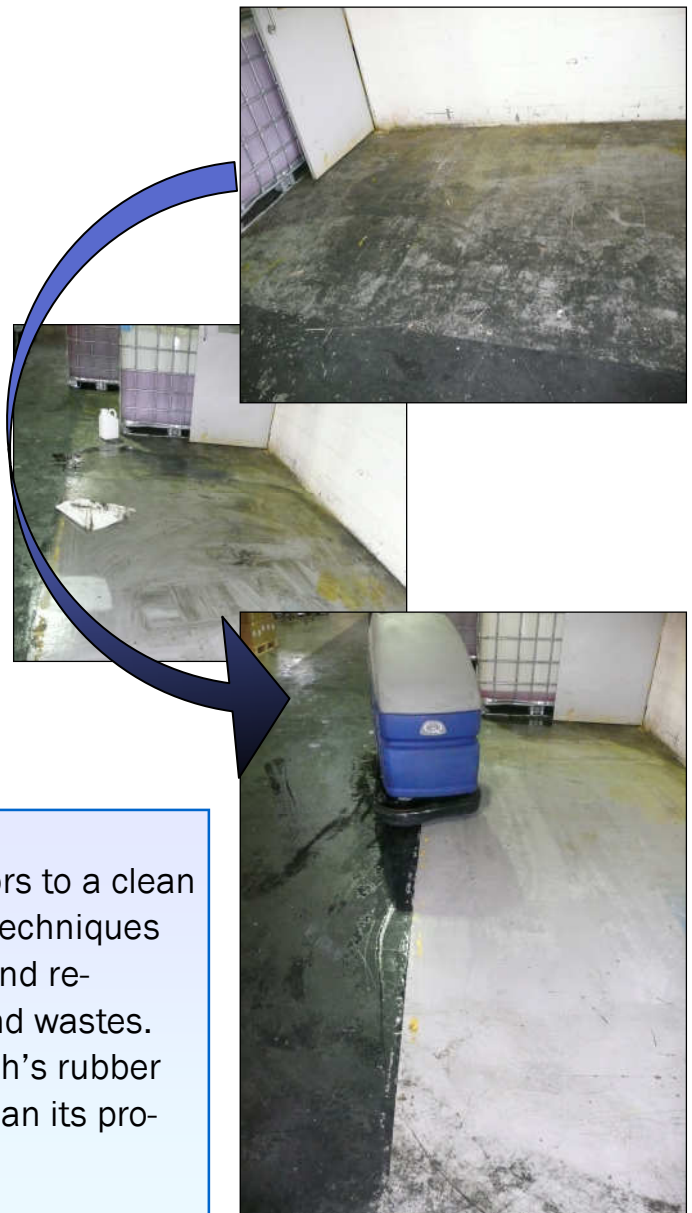
Area 2 treatment details

Heavy Duty Rubber Deposit Remover IP701 was applied with a mop across a production floor area coated with a marked, light grey epoxy surface and covered in places with rubber tyre deposits up to 1 mm thick. The Heavy Duty Rubber Deposit Remover left for 5 minutes and then removed using a scrubber-drier machine charged with a 2% solution of Industrial Hard Surface Cleaner IP712.

Removal of the rubber deposits and re-instate floors to a clean condition without using disruptive and expensive techniques such as shot-blasting or diamond grinding floors and re-coating which generated a fair amount of dusts and wastes. Company has committed to using Global Advantech's rubber deposit removal process during the summer to clean its production and warehouse floors.
