GLOBAL ADVANTECH LIMITED—CASE STUDY

Heavy Duty Rubber Deposit Remover IP701, Industrial Hard Surface Cleaner IP712, High Solids Polymer Sealer IP721

Textile Manufacturing plant

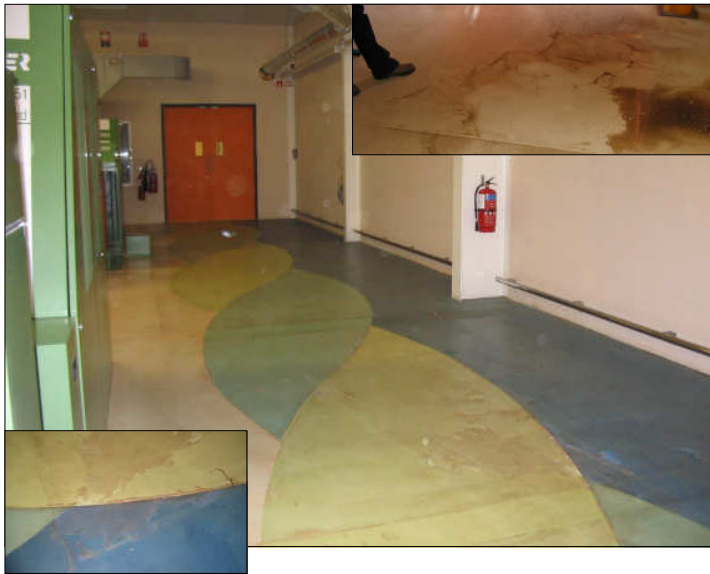
A large spinning mill had been built with a cementaceous screed floor, which had been treated with a polyurethane sealant. Unfortunately, there was a problem with polyurethane sealant and it had not cured properly. During fit-out, the floor became

heavily marked with in ground volcanic dust from the island and rubber tyre marks. Global Advantech's products were used to remove the sealant and to re-seal the floor.

The floor was swept to remove any dust and loose debris, then Heavy Duty Rubber Deposit Remover IP701 was applied to the floor using spray and mops at a rate of approximately 150ml per square metre. After 5 minutes the floor was then cleaned using a scrubber-drier machine fitted with red pads and charged with a 2% solution of Industrial Hard Surface Cleaner IP712. Two passes were used: one where the cleaning solution was put down with scrubbing, but no pick up and a second pass where the floor was scrubbed and the cleaning solution was collected.

When the floor was dry, it was resealed using High Solids Polymer Sealer IP721 applied with a mop at rate of approximately 1 litre to 40 square metres. The sealer dried to leave a high gloss, hard-wearing and easily maintainable finish.
